DASHVILLE DAM

ULSTER COUNTY, NEW YORK INVENTORY NO. N.Y. 76

## PHASE I INSPECTION REPORT NATIONAL DAM SAFETY PROGRAM

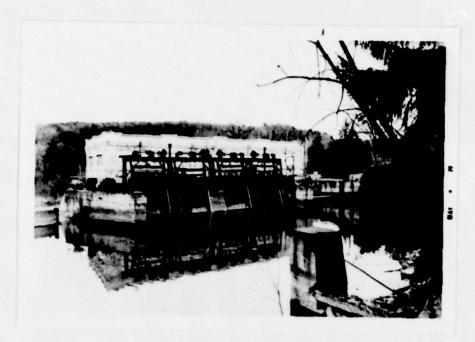
POWER STATION - UPSTREAM

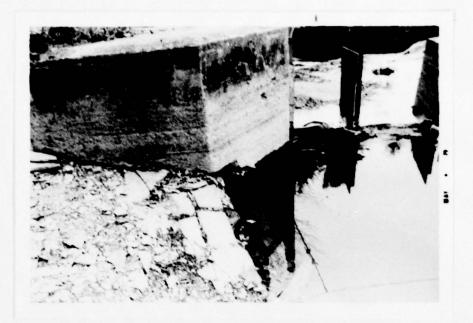
Water flowing over the spillway in the area where the flashboards were opened had scoured some of the backfill from beneath the north-west abutment forming a small void. The abutment is founded on rock, so this hole does not appear to be serious.

NORTHWEST ABUTMENT - TOP OF DAM

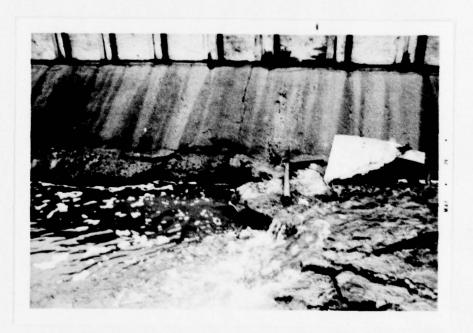
EROSION OF BEDROCK @ SPILLWAY

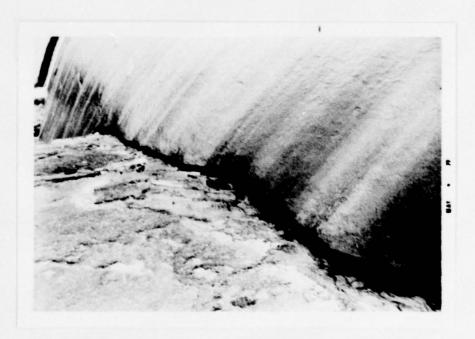
INTERFACE ALONG FOUNDATION AND NON-OGEE SPILLWAY SECTION

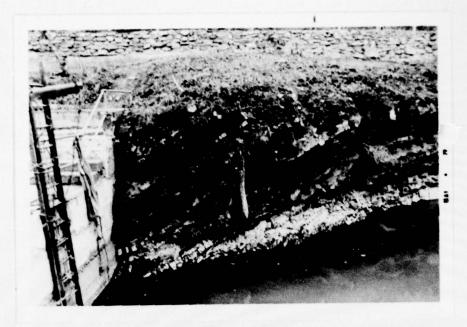
SUBSURFACE STRATA @ POWER STATION
